An Arboricultural Assessment of the Tree Vegetation on the Site Area for 'Phase 2' of the Knockrabo Large Scale Residential Development, Mount Anville Road, Goatstown, Dublin 14.

Prepared for: Knockrabo Investments DAC (Planning Applicant)

**Prepared by: Felim Sheridan F. Arbor. A, RFS Dip, Nat. Dip & NCH in
Arboriculture**

Date: 18th October 2024

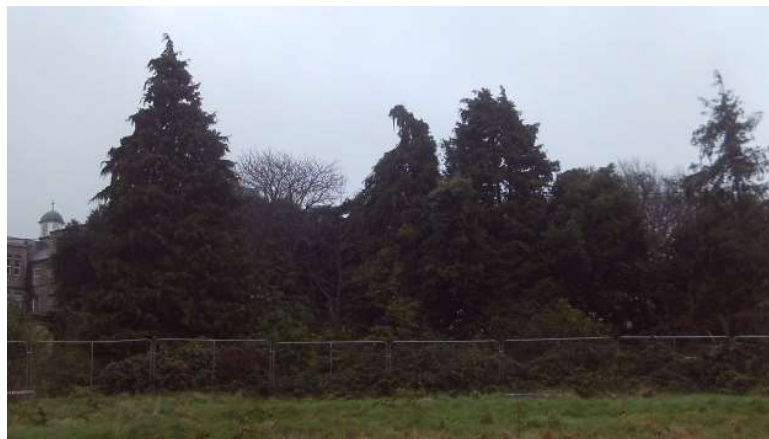
Figure 4 shows Tree Nos. 0678-1391.

Tree No.	Tree Species	Ht. (m)	Stem Dia. (mm)	Branch Spread (m)	C-Ht. (m)	Age Class	Phys Con.	Structural Condition Other Comments	Preliminary Works	Remaining years	Cat. Grade
	Acer spp, Hazel <i>Corylus avellana</i>										
0678	Laburnum <i>Laburnum Anagyroides</i>	8	350	4N 4S 4E 4W	2	Mature	Fair/ Poor	Poor It was initially twin stemmed from base and the secondary stem has recently fallen and is caught up in the overgrowth.	I would recommend it is removal as part of management.	<10	U
0679- 0680	Bay Laurel <i>Laurus nobilis</i>	8	200, 150, 180, 100	2N 2S 2E 2W	0	Early Mature	Fair	Fair. They are growing tight along the boundary wall and they have received little recent maintenance. They are growing as part of this overgrown group area and are multi-stemmed from the base. They provide screening from the road	Tidy up around the base and outer area of dead material branches suckers.	20+	C2
0681 & 0682	Lawson Cypress <i>Chamaecyparis lawsoniana</i>	10	270, 280	2N 1S 1E 1W	0	Mature	Fair	Fair. They have asymmetrical crowns due to overcrowding/competition and they are growing as part of a group. Twin stemmed from the base with an acute union formation between stems between stems. They are in an area which is heavily overgrown.	Tidy up around the base and re-inspect.	20+	B2

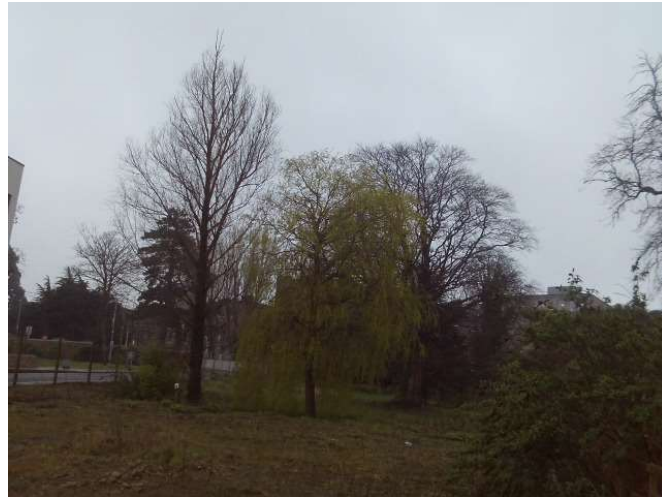
Figure 6 shows Tree Nos.1393 & 0708.

0708	Weeping Willow <i>Salix babylonica</i>	14	400	4N 4S 4E 4W	0	Mature	Fair	Fair/ Poor It grown into a large size tree. The lower branches have been pruned in the past in order to raise up its crown and the fungus 'Phellinus igniarius' is present at one of these wounds at a height of c.2m. It has filled out well but construction and soil level changes have taken place around its base.	Monitor its condition on a twelve-monthly basis.	10+	C2
0710	Copper Beech <i>Fagus sylvatica</i> 'Purpurea'	19	940	6N 7S 6E 6W	4	Mature	Fair	Fair It is a large prominent parkland tree located on the open lawn area and forms part of the original planting on these grounds. It contains deadwood within its crown and there is a bark wound at 0.5m up on its south side of the trunk where decay is developing into the underlying timber. It has received pruning in the past to raise up its crown. There have been some	Remove deadwood. Cut Ivy at ground level at present.	20-40	A2

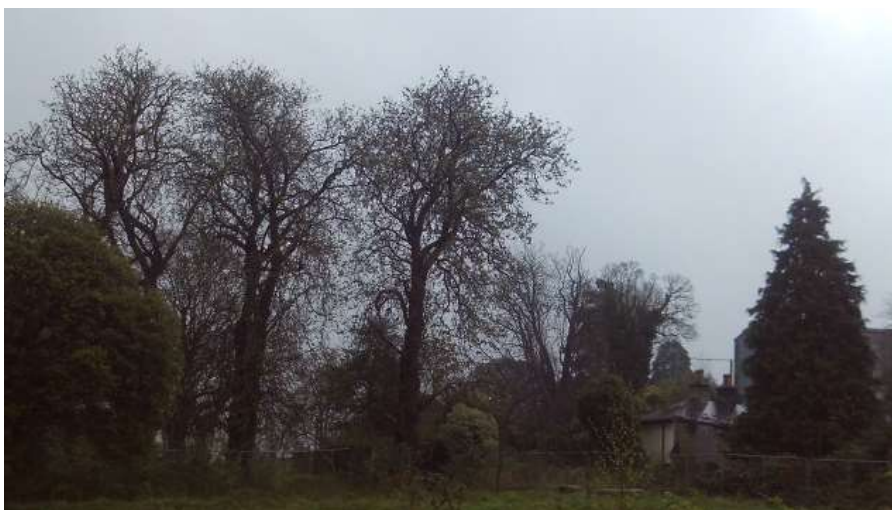
Figure 7 shows Tree Nos.0712-0715.

0712	Horse Chestnut <i>Aesculus hippocastanum</i>	20	980	4N 4S 5E 6W	4	Mature	Fair	Fair It is a large size tree growing up within a group environment and it has been drawn up for the light as a result. Soil rutting/ damage has been caused due to a service track created in the grass area to the west of this tree and this may have had an impact on the health of this tree. Other construction works has taken place close by. It is showing signs of slight sparseness within its crown and is infected by "Bleeding Canker" of Horse Chestnut. There are decay cavities developing up along the main trunk where lower limbs /branches were removed or broke out in the past.	Remove dead/unstable growth. Monitor its condition on a twelve-monthly basis.	10-20	B2
0713	Horse Chestnut <i>Aesculus hippocastanum</i>	21	920	3N 3S 5E 5W	4	Mature	Fair	Fair It divides at a height of c. 3.5m into a twin-stemmed tree with an acute union formation between stems with some included bark present. This has created a structural weakness and it may be prone to failure from	Remove all dead/ unstable growth from within its crown and reduce its crown size by c.3m to reduce pressure on the structurally weak union	10-20	B2

0715	Ash <i>Fraxinus excelsior</i>	23	880	7N 7S 5E 5W	3	Mature	Poor	Poor It is a large prominent tree located out on its own with an independent crown formation. Some lower branches have been removed in the past in order to raise up its crown with decay pockets developing at the larger of the pruning wounds. There is evidence of decline in its upper crown, I suspect as a result of infection by 'Ash Dieback' with a section of the	Due to the extent of the decline, I would recommend it is removal as part of management.	<10	U

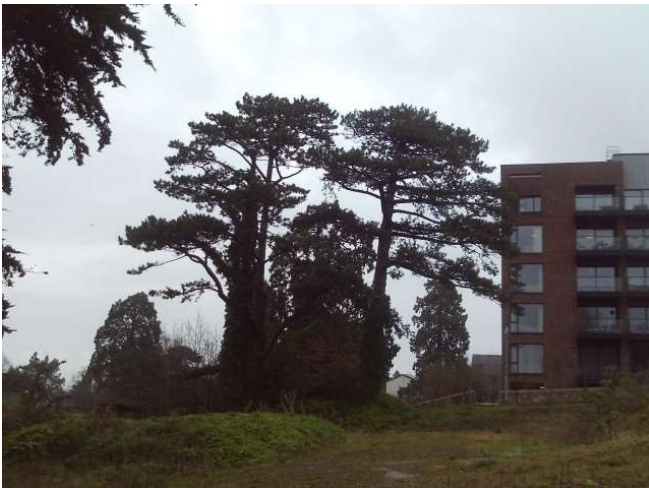
Figure 12 shows Tree Nos.0489 & 0490 two large mature Corsican Pine.

Reason for Removal	Tree No.	Category Grade
Being removed directly due to condition as part of management.	<p>Tree Nos. 0660, 0678, 0693, 0715, 1392, 0741 & 0492. These trees are in poor condition physiologically and/or structurally with limited remaining life expectancy and their removal is being recommended as part of active management. These trees are not directly affected by the proposed development layout.</p>	<p>U (7No. Tree entries)</p>
Being removed directly due to the development layout.	<p>Tree Nos. 1389-1390, 0489 & 0490. These trees are also in poor condition physiologically and/or structurally with limited remaining life expectancy and their removal is being recommended as part of active management irrespective of the development going ahead.</p> <p>Tree Nos. 0710 & 0711. Tree No.0710 is a large prominent mature Copper Beech of some prominence within the treescape of this area and forms part of the earlier tree planting. Tree No.0711 is a semi mature Blue Cedar of good quality but currently of a relatively small size and not prominent within the treescape of the greater area yet, but in time has the potential to contribute to this.</p> <p>Tree Nos. 1397 & 1398 These are two relatively young Wellingtonia trees planted in more recent years as part of the landscaping on this house and currently of a size where they are not significant within the treescape of the greater area.</p> <p>Tree Nos. 0661, 0684, 0685, 1388, 1391, 1393, 0708, 0765, 0802, 1399-1400, 0804 & Tree Nos.1 – 4.</p> <p>Tree groups 1, 2 & 3 (0722-0733).</p> <p>Hedge Nos.1 & 2 and scrub area No.1.</p>	<p>U (3No. tree entries)</p> <p>A1 (2No. tree entries)</p> <p>B1 (2 No. tree entries)</p> <p>C1 (15No. Tree entries)</p> <p>C2 (3No. group entries)</p> <p>C2 (3No. entries)</p>
