REPORT ON THE ARCHITECTURAL/HISTORIC SIGNIFICANCE  
OF THE KNOCKRABO SITE AND SETTING,  
MOUNT ANVILLE ROAD, DUBLIN 14

OBSERVATIONS ON THE IMPACT OF THE  
CURRENT PROPOSAL

October 2024 – FINAL Rev 4

## **Report On the Architectural/Historic Significance of the Knockrabo Site and Setting, Mount Anville Road, Dublin 14 And Observations On The Impact Of The Current Proposal**

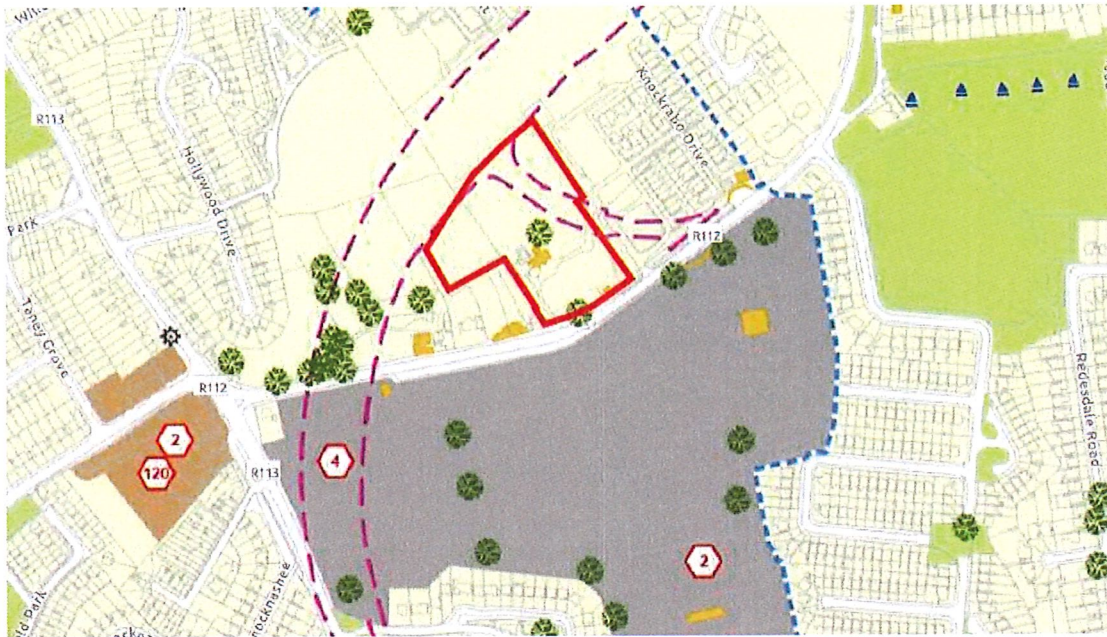
Figure 1: Extract from the Dún Laoghaire – Rathdown Development Plan 2022-2028. The red outline indicates the subject development site and was added by David Slattery Conservation Architects. The yellow solid hatch shows the Protected Structures.

The subject development site is zoned A under the Dún Laoghaire - Rathdown County Development Plan 2022-2028 (see Fig.1) with the objective "*To provide residential development and improve residential amenity while protecting the existing residential amenities.*"

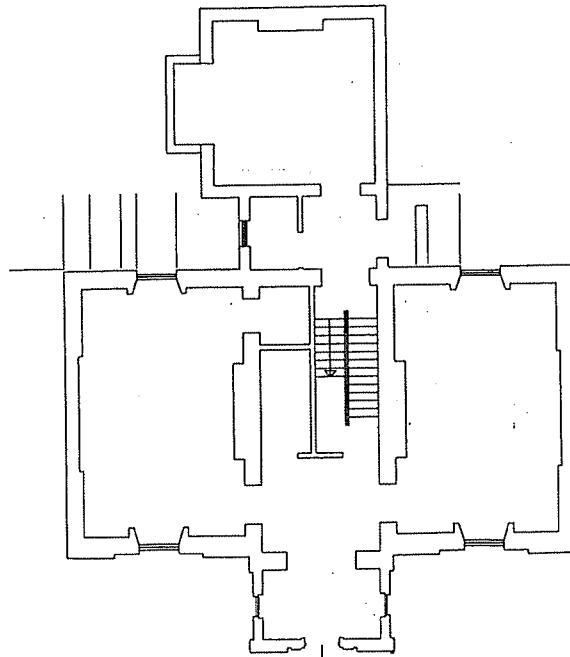
*Figure 2: Cedar Mount House Existing Ground Floor Plan, Extract from Robin Mandal Impact on Architectural Heritage prepared in 2001. It shows the non-extant Edwardian Wing to the north.*

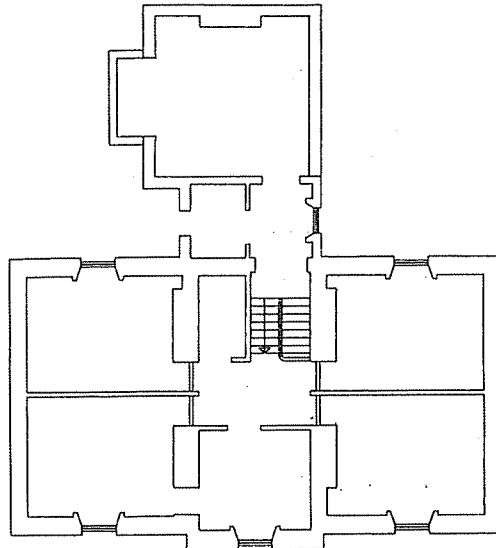
*Figure 3: Cedar Mount House First Floor Plan, Extract from Robin Mandal Impact on Architectural Heritage prepared in 2001. It shows the non-extant Edwardian Wing to the north.*

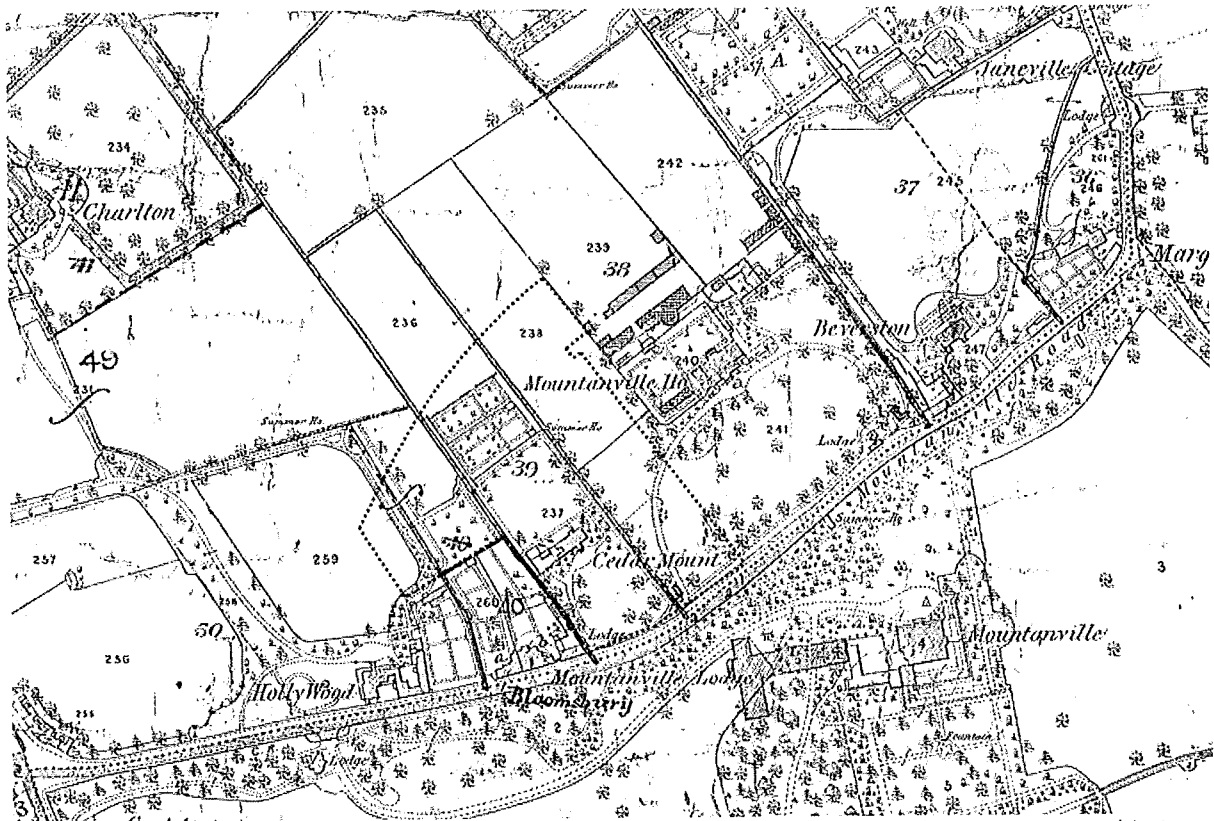
Figure 7: Extract from the OS Map 1865-1866. The red dashed outline indicates the approximate subject development site.

This map provides more details. Mountainville House seems to have been extended to the west. Outbuildings and conservatories appear to the northwest and west. A front garden with a path is clearly shown. Three gate lodges appear to the front, one on the southwest and two on the southeast. Boundary walls seem to be drawn to the east and west with a section to the north where it is written Summer House.

Mountainville Lodge (former 'Thendara' and the 'The Garth') plots seems to have been reduced to the north. There is a boundary wall to the east, west and north of those buildings. Paths appear to the rear. The west boundary wall extends all along the Hollywood House plot.

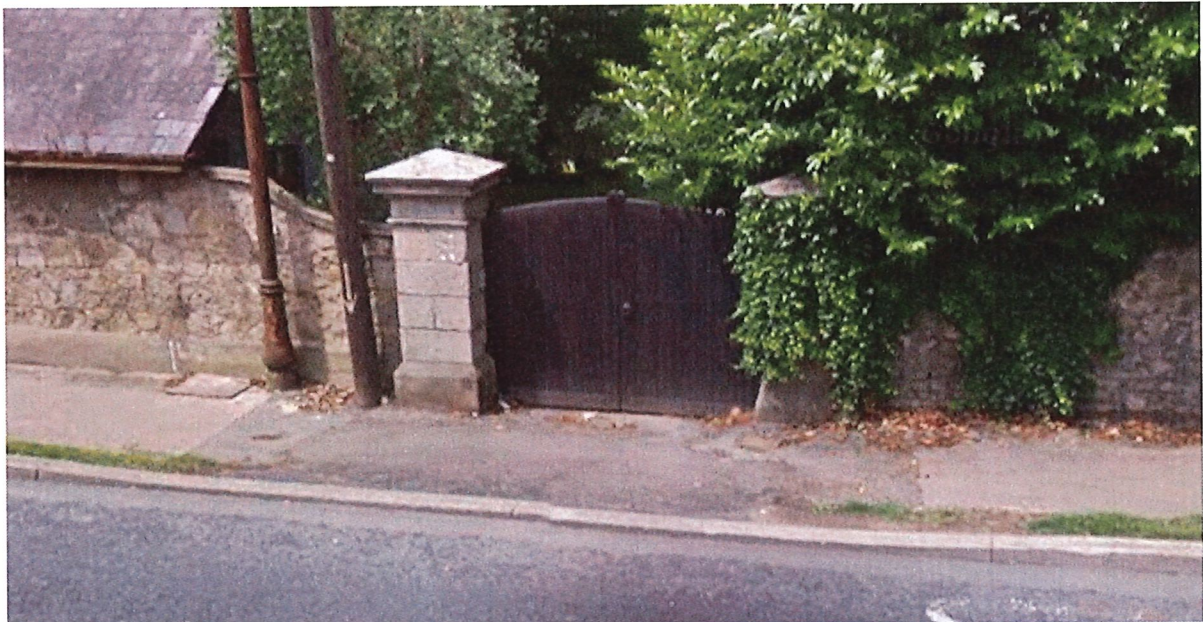
*Figure 11: View of gate piers and gates which appear not to be original.*

The carved granite piers and painted, boarded, timber gates to the east of the Gate Lodge are inscribed separately on the DLR RPS.

The carved granite piers are significant historic fabric and contribute to the character of the streetscape and as a logical context to the adjacent Gate Lodge. The timber gates do not appear to be original but are, nevertheless, inscribed on the RPS and should be retained and repaired.

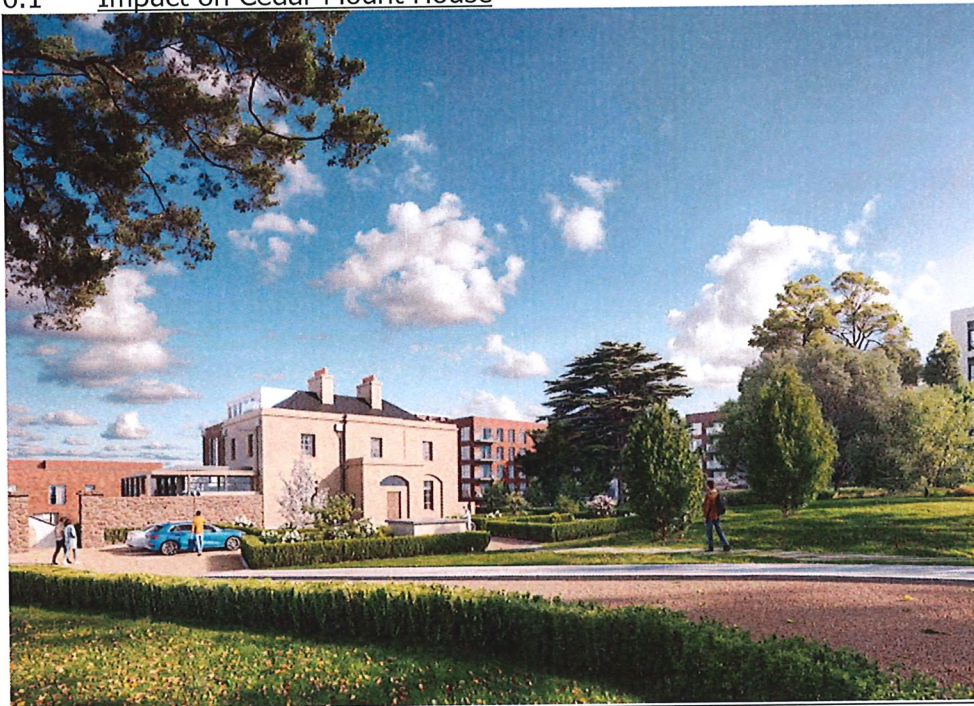
*Figure 13: Proposed CGI 03. Cedar Mount House, looking north. Source: Model Works.*

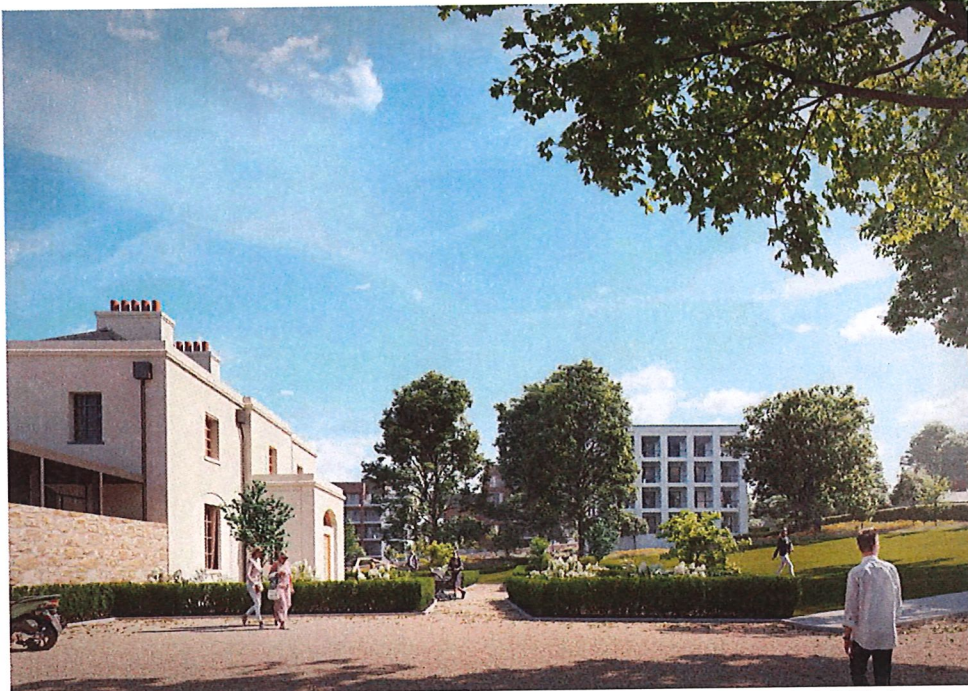
Figure 14: Proposed CGI 07. Cedar Mount House, looking east. Source: Model Works.

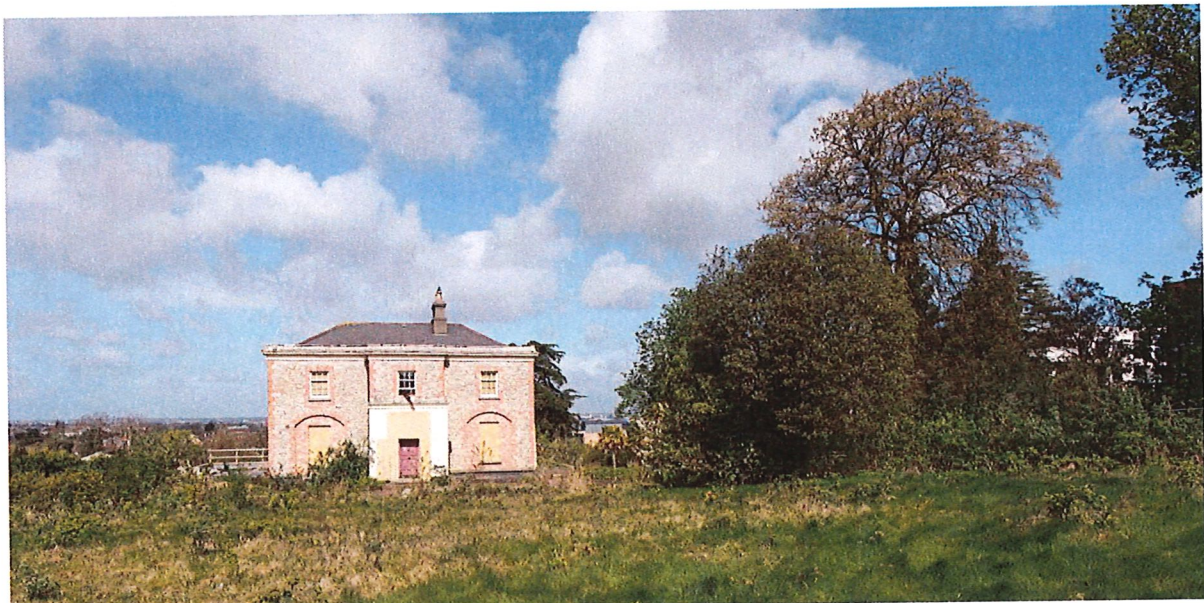
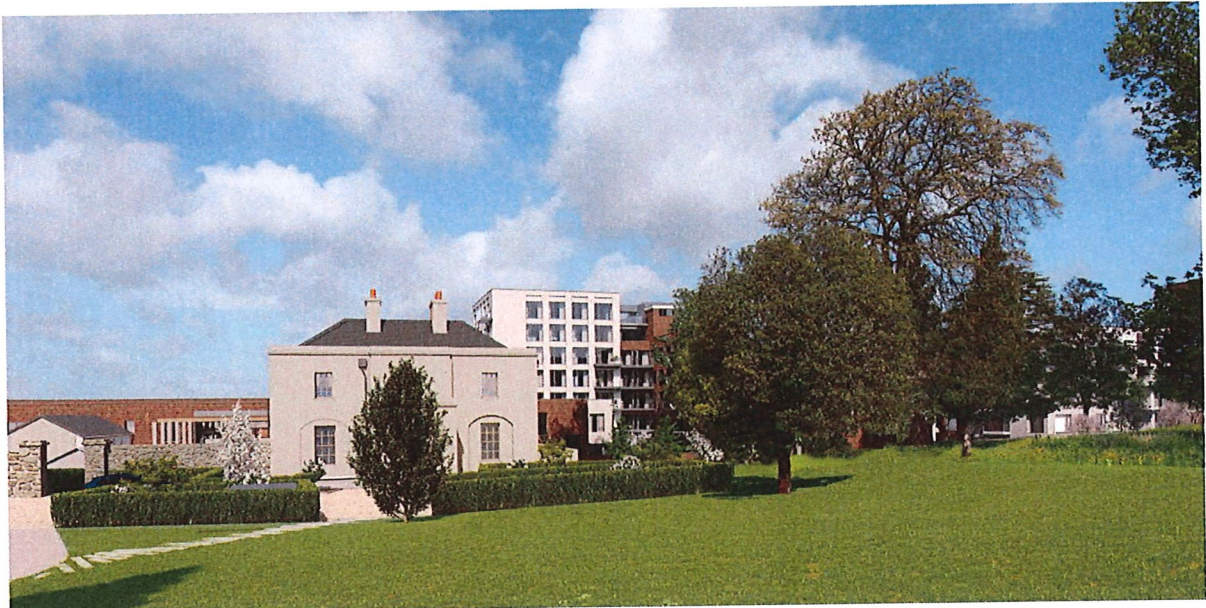
Figure 15: Existing Viewpoint 2. Source: Model Works.

Figure 16: Proposed Viewpoint 2. Source: Model Works.

Cedar Mount House appears on the 1837-1838 First Edition to the OS and was likely constructed between c. 1800-1820. The 1865-1866 Revision to the OS shows that the original curtilage was defined to the front by Mount Anville Road, to the west by a boundary wall where the Coach House is located and to the east by a boundary wall that no longer exists - probably in line with where the mature trees stand today. The original curtilage to the rear extended far beyond the current site boundary. As such, the proposed Block E lies outside of the historic Cedar Mount House curtilage. The impact of Block E on Cedar Mount House and its front setting is minimal. The proposed Block E is five-storey high including a semi-basement podium level. It is located at some distance (46 m.) from Cedar Mount House. In addition, the existing mature trees provide screening between Block E and Cedar Mount House.

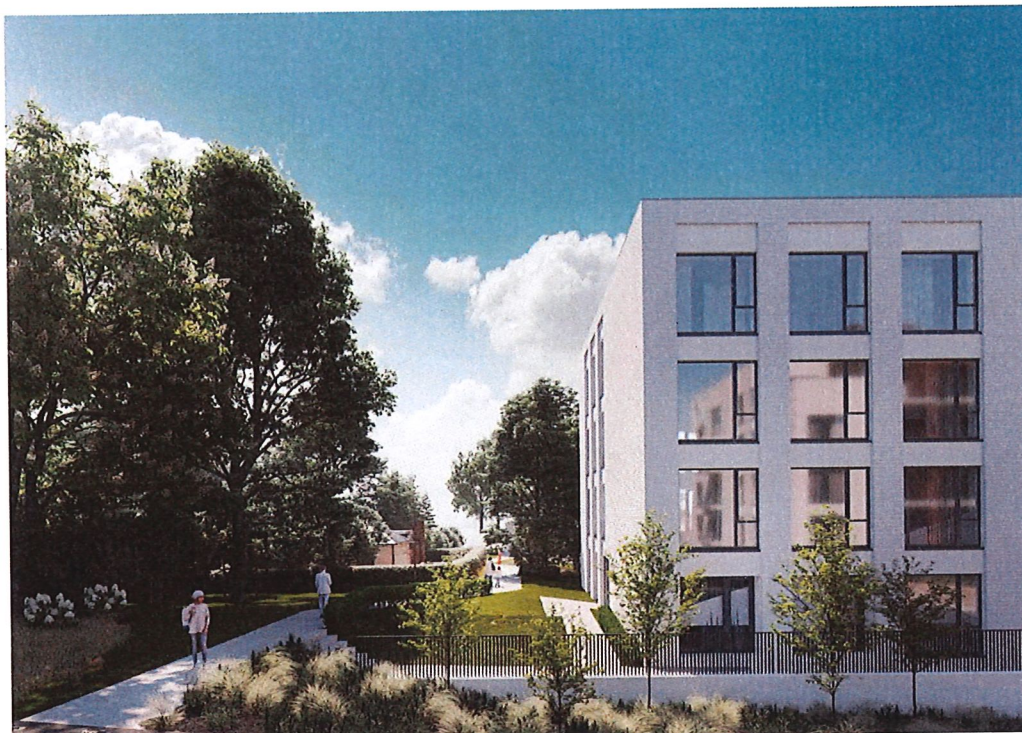
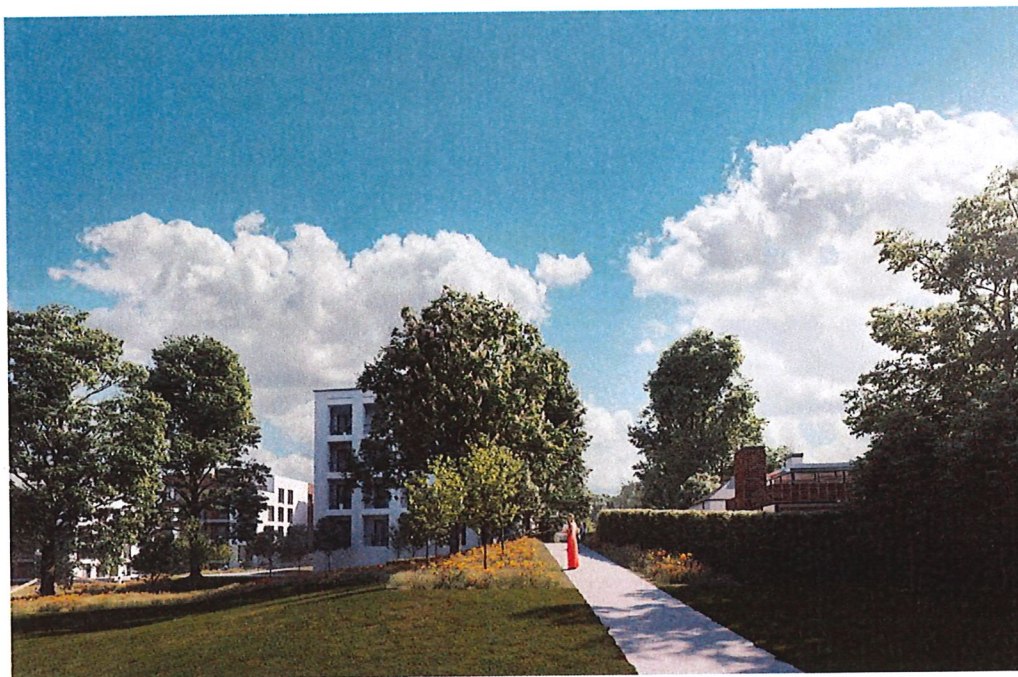
Figure 17: Proposed CGI 08. Proposed Block E and Knockrabo Gate Lodge (West), looking west. Source: Model Works.

Figure 18: Proposed CGI 10. Proposed Block E and Knockrabo Gate Lodge (West), looking east. Source: Model Works.

Knockrabo Gate Lodge (West) was built between 1865 and 1910 as the secondary gate lodge of the no-longer extant Mount Anville House. Its association with the former Mount Anville House contributes to its significance. However, this Gate Lodge lost its original curtilage with the demolition of Mount Anville House in 1984 and was cut from its curtilage due to the new

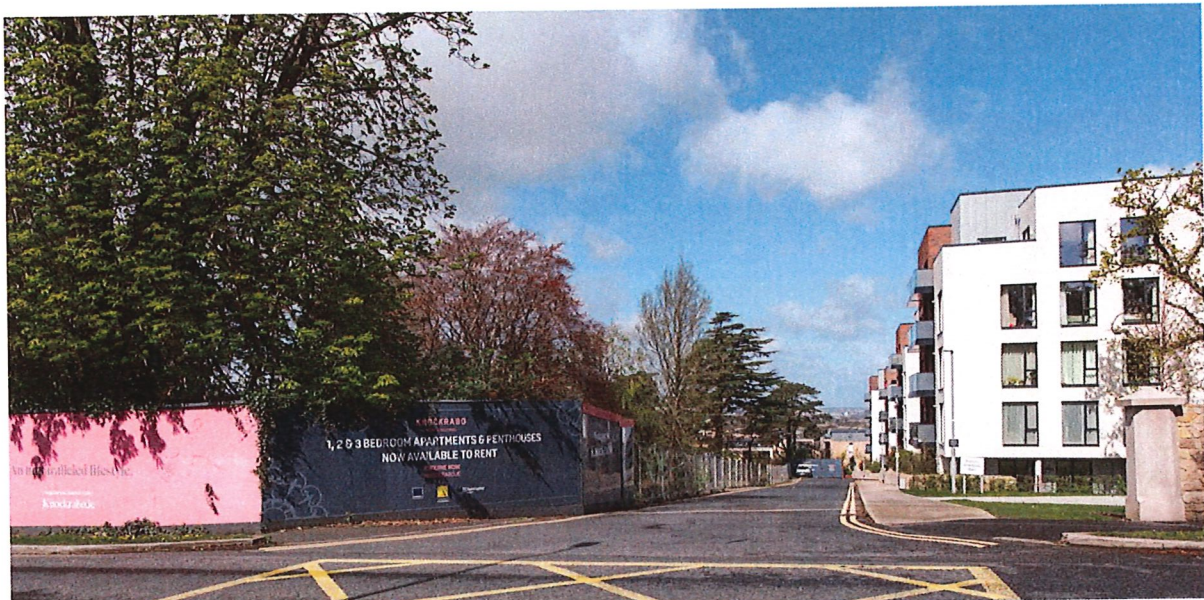
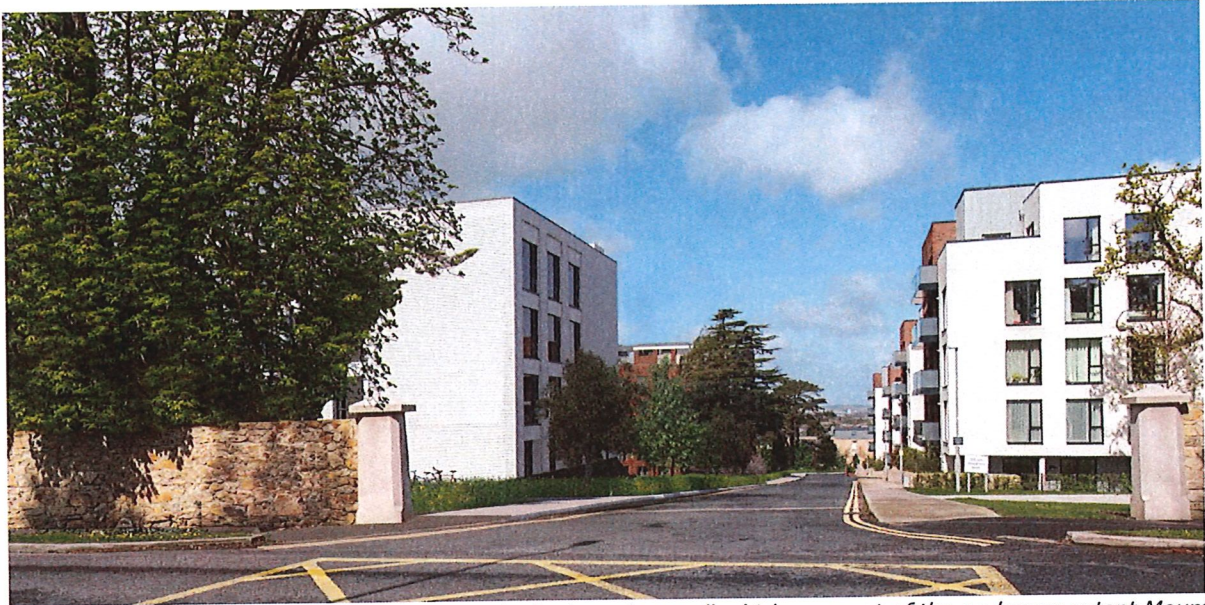
Figure 19: Existing Viewpoint 1. Source: Model Works.

Figure 20: Proposed Viewpoint 1. View towards the boundary wall which was part of the no-longer extant Mount Anville Road. Source: Model Works.

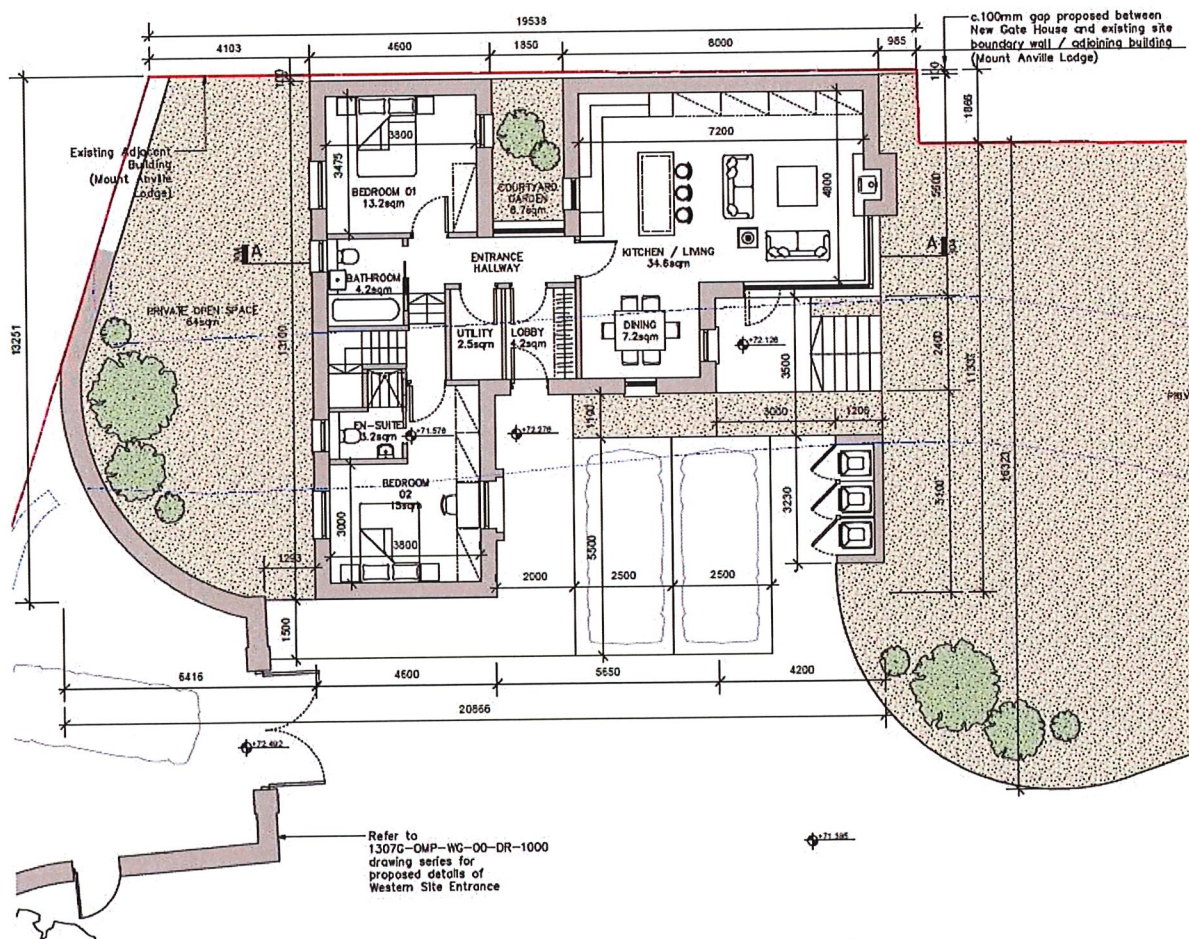
Figure 11: Gate Lodge, Proposed Ground Floor plan. Source: O'Mahony Pike Architects.

The proposed new Gate Lodge will be set back from the Entrance Gate and piers. It will have no impact. In addition, will have no impact on the setting as there was a Gate Lodge which is shown on the 1865 OS map and was demolished after 1937.

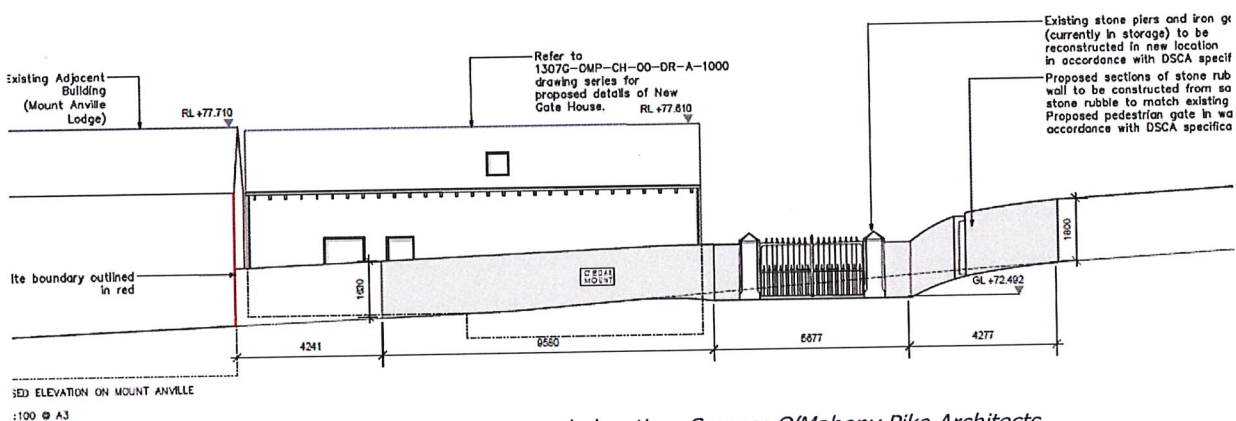
Figure 12: Entrance to Cedar Mount House proposed plan. Source: O'Mahony Pike Architects.

Figure 13: Entrance to Cedar Mount House proposed elevation. Source: O'Mahony Pike Architects.

The works including the relocation of a section of the wall and piers with the gate to the Entrance Gate will not be significant and are necessary for traffic engineering reasons. The removal of inappropriate cement-based ribbon pointing will be replaced with a lime-based mortar with a brush-backed flush finish. The works will ensure the maintenance of the front boundary wall and enhance its character and will be carried out in accordance with the Conservation specifications (See Appendix 7).

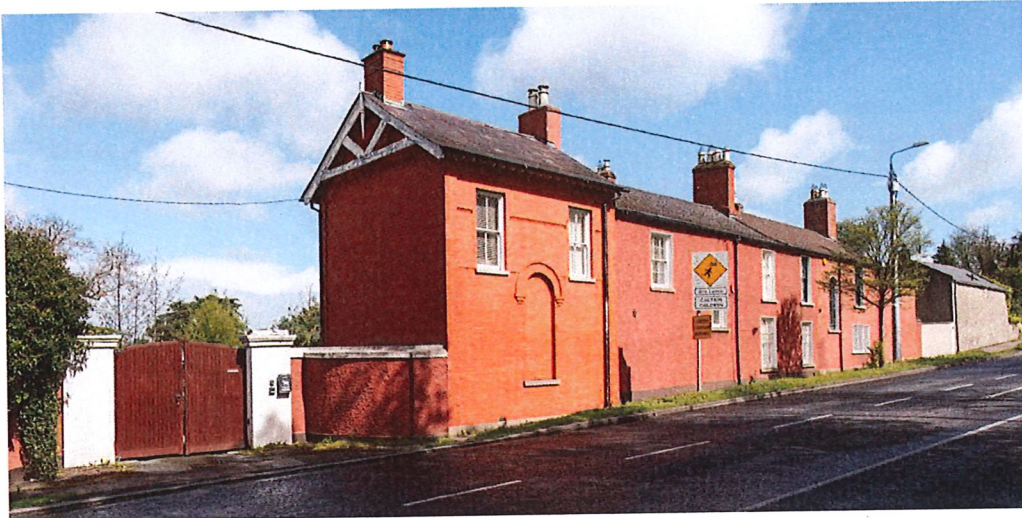
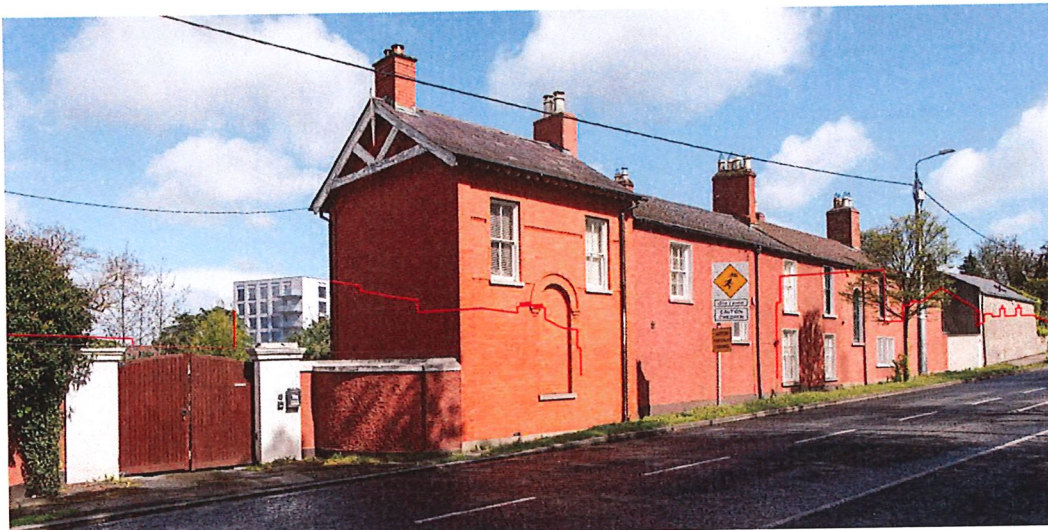
Figure 21: Existing Viewpoint 11. Source: Model Works.

Figure 22: Proposed Viewpoint 11. Source: Model Works.

The impact of the proposed development to the rear of those structures is likely to be imperceptible as they are separated from the subject development site by a high stone boundary wall which appears clearly on the 1865 OS Map.

The viewpoint 11 shows that the proposed Block F is partially visible from this view. However, the proposed development will not have a significant effect due to the distance from the proposed Block F to The Garth and Thendara and the height of the proposed block. The proposed development does not detract from the architectural character of the Protected Structures.

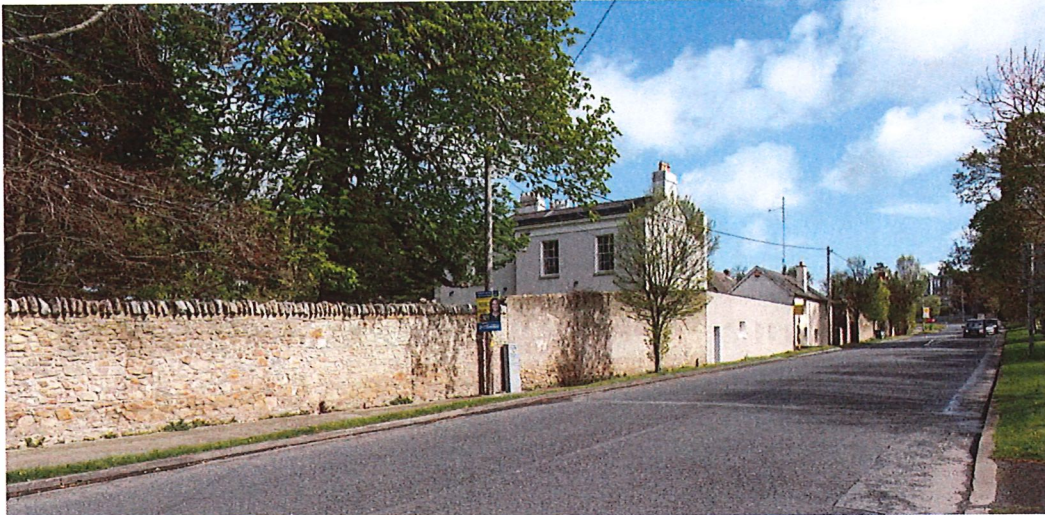
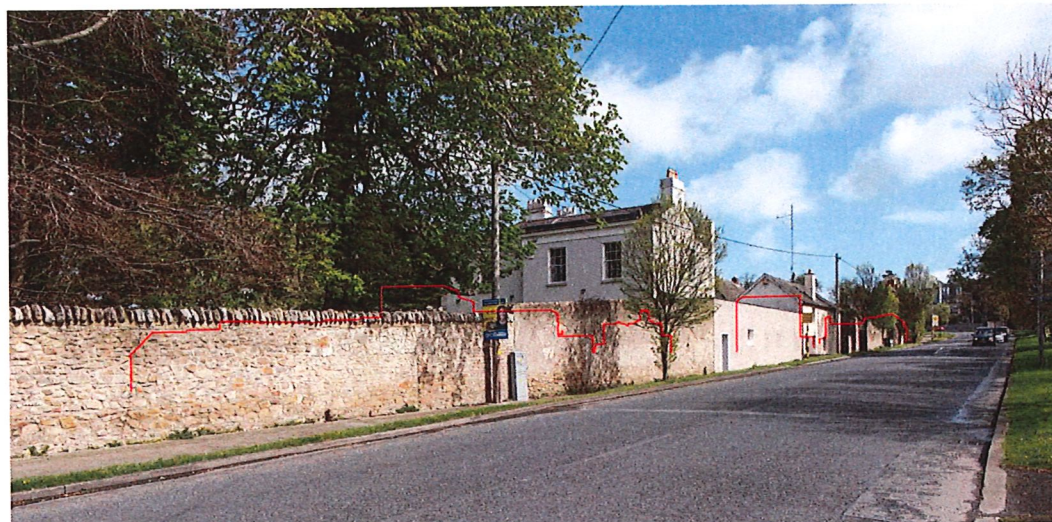
Figure 23: Existing Viewpoint 12. Source: Model Works.

Figure 24: Proposed Viewpoint 12. Source: Model Works.

The effect on Hollywood House will be imperceptible as there is a 1837-1865 stone boundary wall running behind the plot of the 'Thendara' and 'The Garth' to the limit of Hollywood House. There is also a stone boundary walls running to the west of the subject development site. Those walls and the existing mature trees will provide a screening for Hollywood House.
